# Maritime Helicopters

## Second Quarter 2019 Quality & Safety Notes

## First Quarter 2019 Quality & Safety Notes

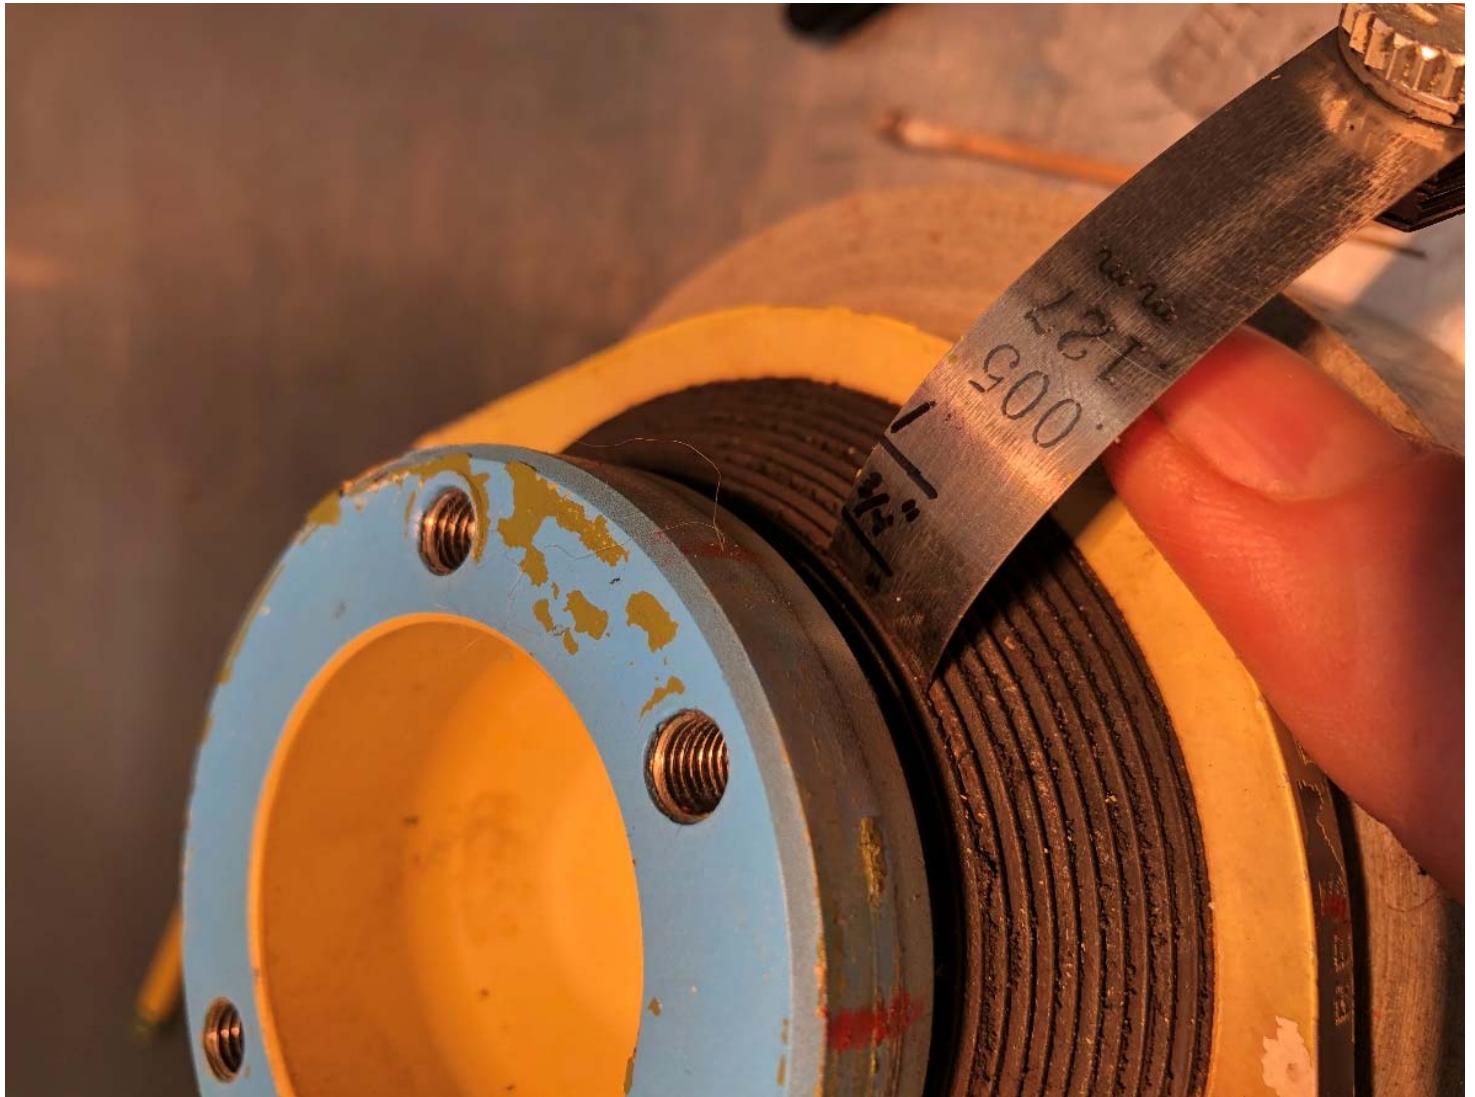
**GOR 201901: 03/28/2019 Bell 407 (elastomeric bearings failing)**

Inspection of the aircraft on the ground showed that two of the four elastomeric bearings on the rotorhead were deteriorated to the point of needing replacement.

*This seems like a simple enough story: But there are several things to capture for corrective action. A class is being prepared on the inspection of these elastomeric bearings and how to identify when they are failing. That's the simple fix. All of us getting more educated on elastomerics. However, we have the larger issue of when we make the call as to whether inflight vibration is bad enough to ground the aircraft. Had the crew performed track and balance procedures, the vibration would likely NOT have been fixed, and then a closer inspection of the bearings would had to have been done.*

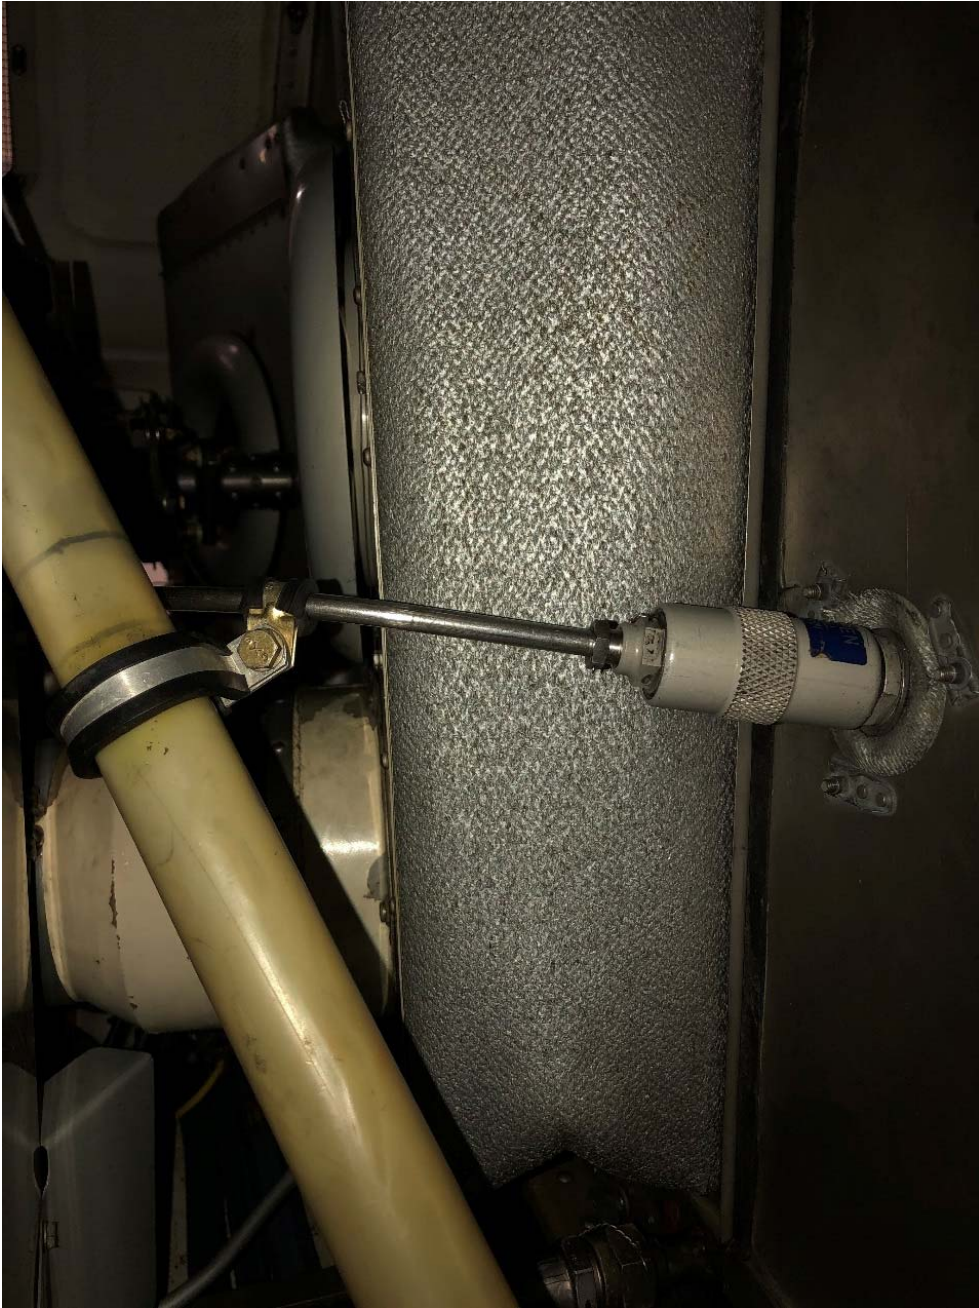
**GOR 201902: 2/08/2019/1000 BO105 (Teleflex Cables Binding)**

Several complaints & several months of troubleshooting and engine rigging procedures, the aircraft was brought down to AOG status for troubleshooting of engine beep controls and matching. The number one engine was slow to respond to beep trim and correspondingly, the number two engine would seem "stuck" in one place. The "final straw" was on a check ride, when neither the check airman nor the right seat pilot could seem to achieve both engines to be matched in torque output.

After several attempts to accomplish aircraft rigging by the book, it was found that the engine control (Teleflex) cables were binding within the control cable tubes. Both engine's cables and cable tubes were replaced and a successful rigging and operational check of the engines was accomplished.

*This picture is the Teleflex tube, forward of the engine bulkhead...not really where the binding was occurring, but you get the picture. The theory goes that the binding was just aft of the bulkhead.*

*(A change to the AAIP should be forthcoming to add a check of the Teleflex cables condition. A "smoothness" check using the hydraulic mule could accomplish this task)*
