# Maritime Helicopters

## 2<sup>nd</sup> & 3rd Quarters 2023 Quality & Safety Notes

## First Quarter 2023 Quality & Safety Notes

## First Quarter 2022 Quality & Safety Notes

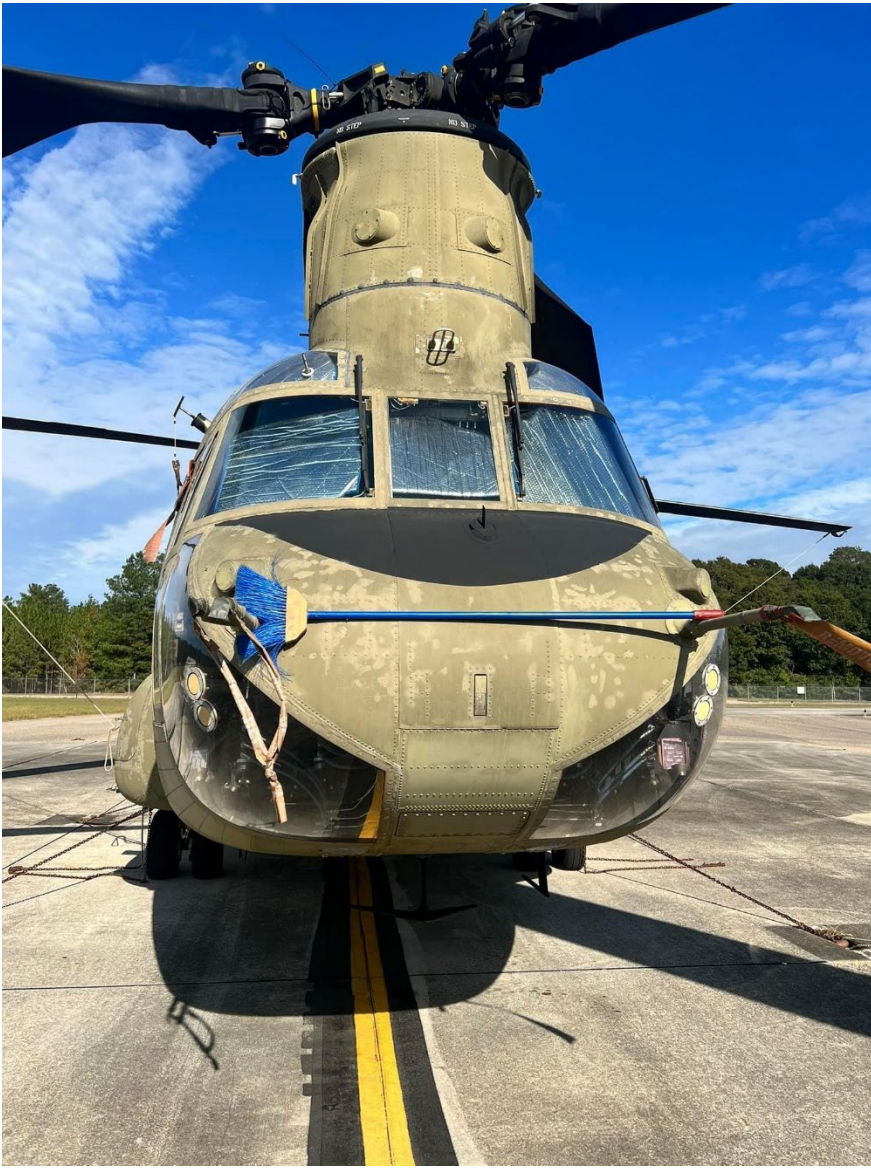
We had one "double duck" bird strike this year. That dinged an engine exhaust. Could have been much worse.

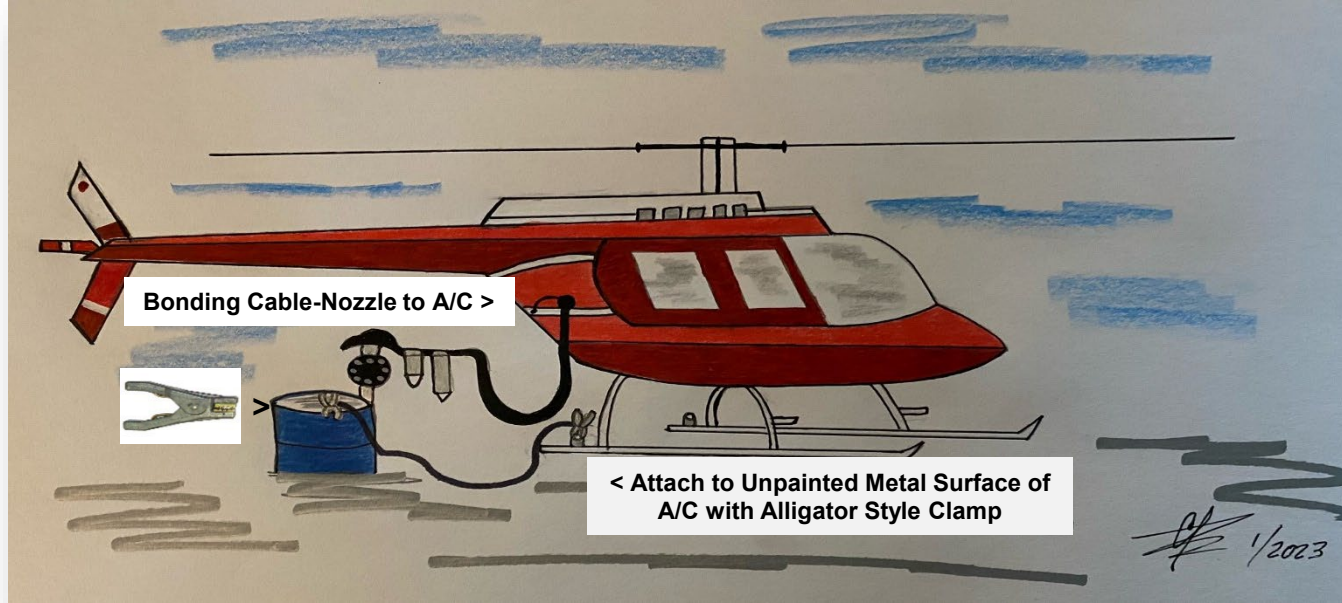
**Bonding Cable  
Between  
Drum & to A/C**

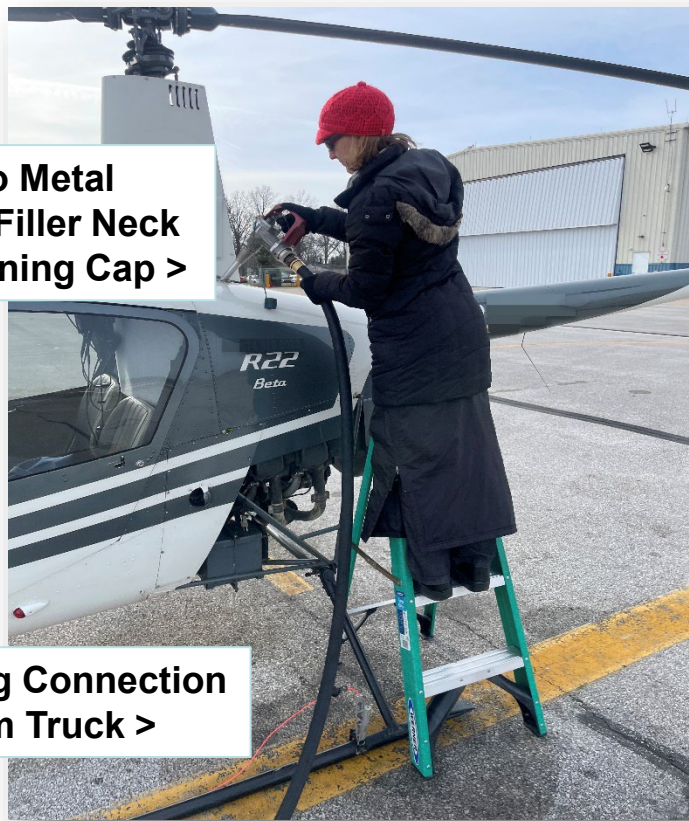
**Metal to Metal  
Contact w/Filler Neck  
Before Opening Cap >**

**Bonding Connection  
from Truck >**
